Test report BM 10/14-7

Examination of the bio-deterioration of the sample material according to DIN EN ISO 846

MEZ-AEROSEAL*, color white

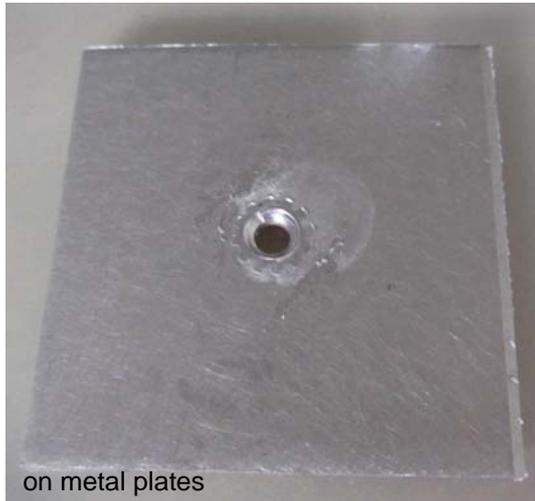
Photo 1: Material **MEZ-AEROSSEAL, color white** fungal growth was not visible to the naked eye

On the surface of material **MEZ-AEROSEAL, color white** fungal growth was not visible to the naked eye, but was partly visible under the microscope. Bacterial growth was not visible to the naked eye, but was partly visible under the microscope.

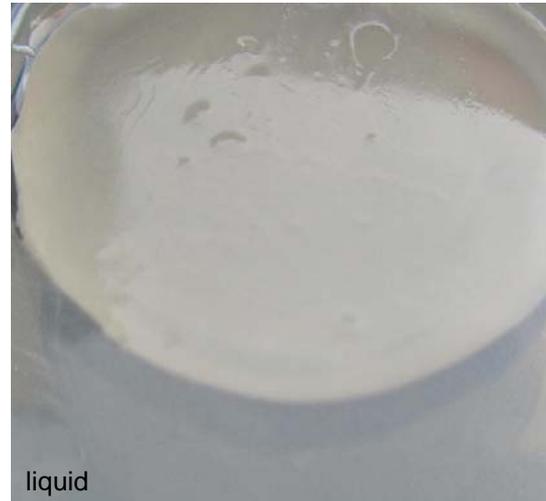
Photo 2: Material **MEZ-AEROSSEAL, color white** bacterial growth was not visible to the naked eye

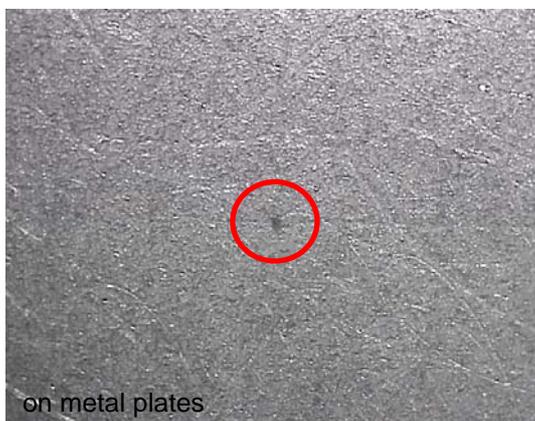
Photo 3: Material **MEZ-AEROSSEAL, color white** (at a magnification of x 50): fungal growth was visible under the microscope

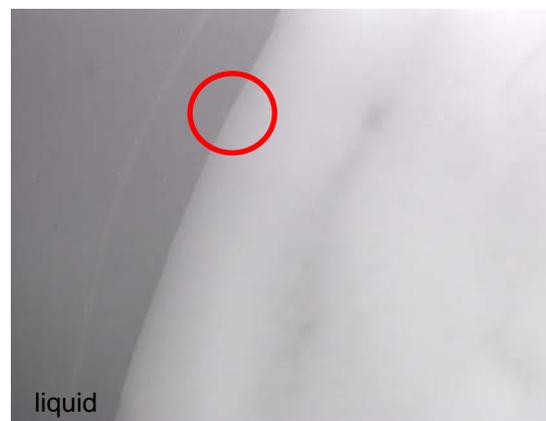
Photo 4: Material **MEZ-AEROSSEAL, color white** (at a magnification of x 50): bacterial growth was visible under the microscope
